**Address of Inspection** 59B Kitemoana Street, Orakei, Auckland.

**JOB NUMBER:** 5339

**INSPECTION TYPE:** Third party/special purpose Report- Leak detection

To inspect the Kaitiaka 'Whata' due to some historic leakage and determine a method to reduce leakage.

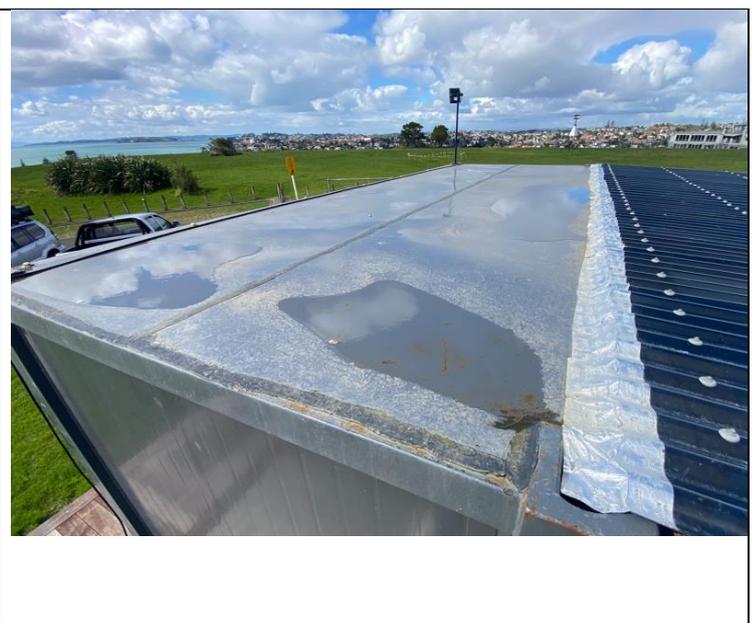
<p><b>Location: Roof</b></p>

<p><b>Material/Item:</b> Coated metal sheet with painted steel container structure. Timber framed front roof cover with polycarbonate roofing.</p> <p><b>Defect:</b> This roof surface has depressions that are holding water in some areas. This is mostly a concern around the connection of the polycarbonate roof connection and along the eastern side where surface fixings are present. The polycarbonate roof conceals the junction where the pop-out section is connected so this is not able to be closely inspected. It would be recommended to undertake some repair testing to see if the internal leakage is reduced.</p>	
<p><b>Next action:</b> We recommend removing the aged aluminium/butanol tape over the roof join and using spirits to clean the areas before re-fitting a new temporary tape to the area. The metal must be clean and dry to ensure a good seal. This temporary repair will test to see if the visible lifting of the existing tape is allowing wind driven rain to access and leak around the roof junction and fixings that hold the timber structure in place. If this reduces leakage a more permanent solution could be undertaken.</p> <ol style="list-style-type: none"> <li>1- flashing could be fitted to the roof junction.</li> <li>2- Flashings fitted to the edge of the container.</li> <li>3- Look to create a pitched roof over the back/eastern side container to allow for better flashing.</li> </ol>

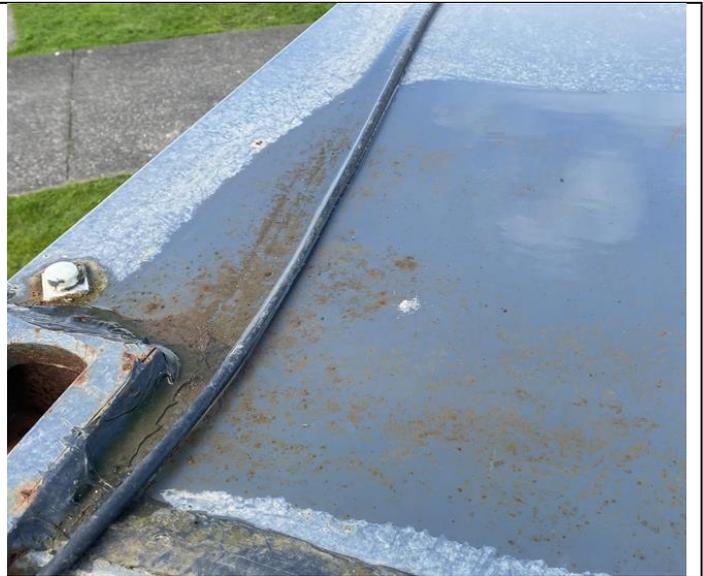
<p><b>Location: Roof</b></p>

<p><b>Material/Item:</b> Coated metal roof with plastic fixing covers</p>	
<p><b>Defect:</b> The white plastic fixings look to be possibly covered for an underlying fixing, but I could not remove this due to risk of damage to the cover. We have noted gaps around these fixings and the pooling water elevates the risk of leakage.</p>	
<p><b>Next action:</b> These areas should be cleaned with spirits and sealed. The fixings should be loosened so that silicone can pass to the thread and a new EPDM rubber washer fitted to ensure a good seal. We would need to remove one of thee to investigate what the fixing is etc.</p>

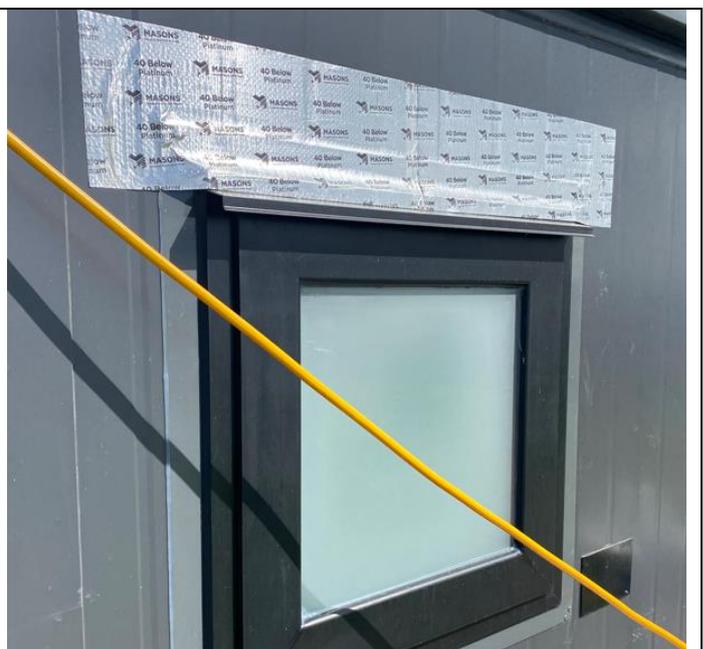
<p><b>Location: Eastern wall</b></p>

<p><b>Material/Item:</b> aluminium window and coated metal wall lining</p>	
<p><b>Defect:</b> We have been unable to confirm how the windows are flashed off. With noted leaking internally a detail tape has been fitted to seal this smaller window. This should be also done to the left side window to confirm that leakage is reduced and if so a permanent factory coated metal flashing could be fitted that passes up under the roof flange.</p>	
<p><b>Next action:</b> Tape the left side window as this smaller one has been. If successful fit permanent flashings.</p>
